CONNECTICUT RIVER BASIN
RUSSELL, MASSACHUSETTS

COBBLE MOUNTAIN RESERVOIR DAM
MA 00068

PHASE I INSPECTION REPORT
NATIONAL DAM INSPECTION PROGRAM

MARCH 1980

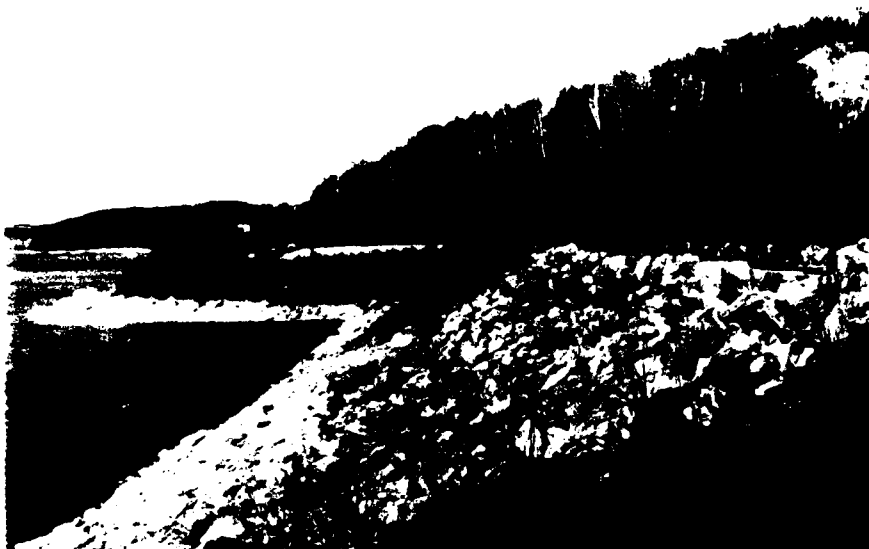
Photo 1

Upstream face of dam,
looking north at left end

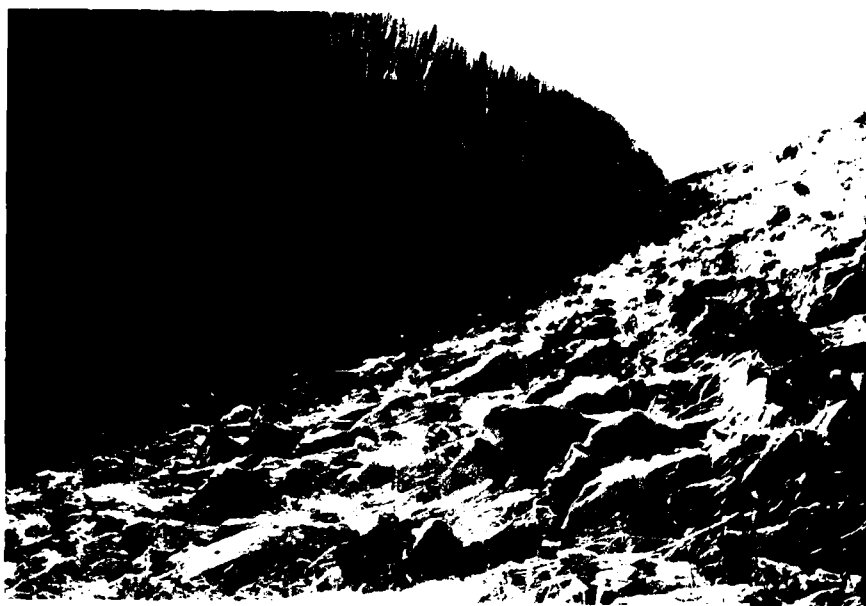
Photo 5

Downstream face of dam,
mid height, showing rock,
spauls and growth

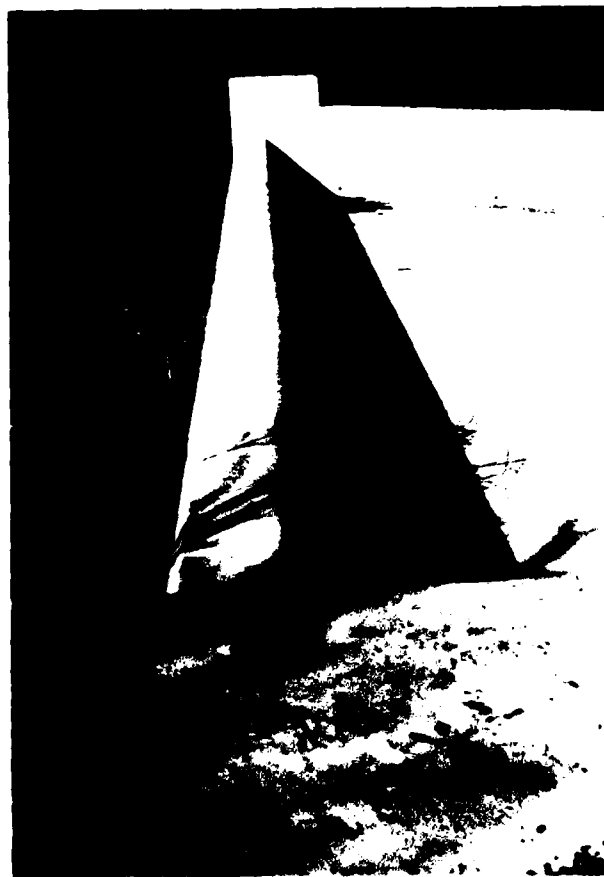
Photo 13

Spillway crest wall from right (southeast) abutment.

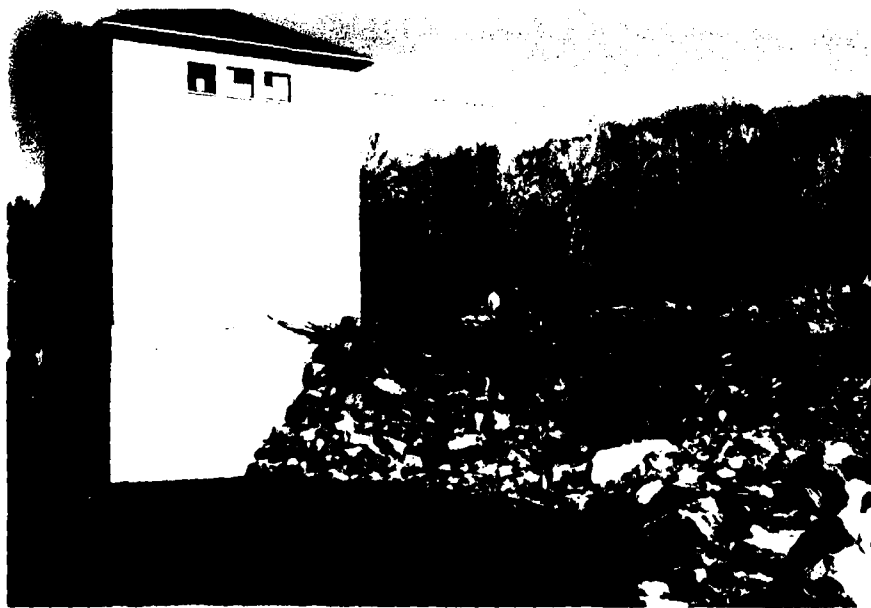
Photo 19

Maximum reservoir levels
Aug. 1955, and Oct. 1955;
at intake gatehouse, showing
typical good condition

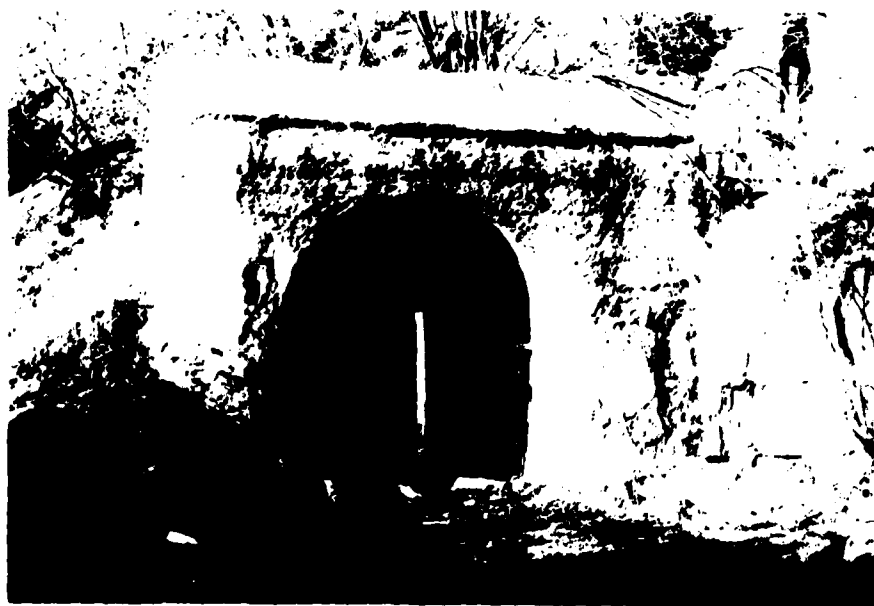
Photo 29

Diversion tunnel, showing leakage, in last 340 ft.
